## Sites Dam Site

The Sites Dam site is in a narrow, V-shaped water gap on Stone Corral Creek about a quarter of a mile east of the town of Sites and 8 miles west of the town of Maxwell in Colusa County (Photo 2). It is in Sec. 20, R4W, T17N on the Sites 7.5-minute USGS topographic quadrangle. The proposed dam, in conjunction with the Golden Gate Dam and the Sites northern saddle dams, would impound 1.8 million acre-feet of water in Sites Reservoir. The dam would be a 277-foot high embankment structure with a 900-foot crest length at an elevation of 540 feet. No spillway is associated with Sites Dam. The only spillway is part of the Golden Gate outlet works just south of the Golden Gate Dam site.

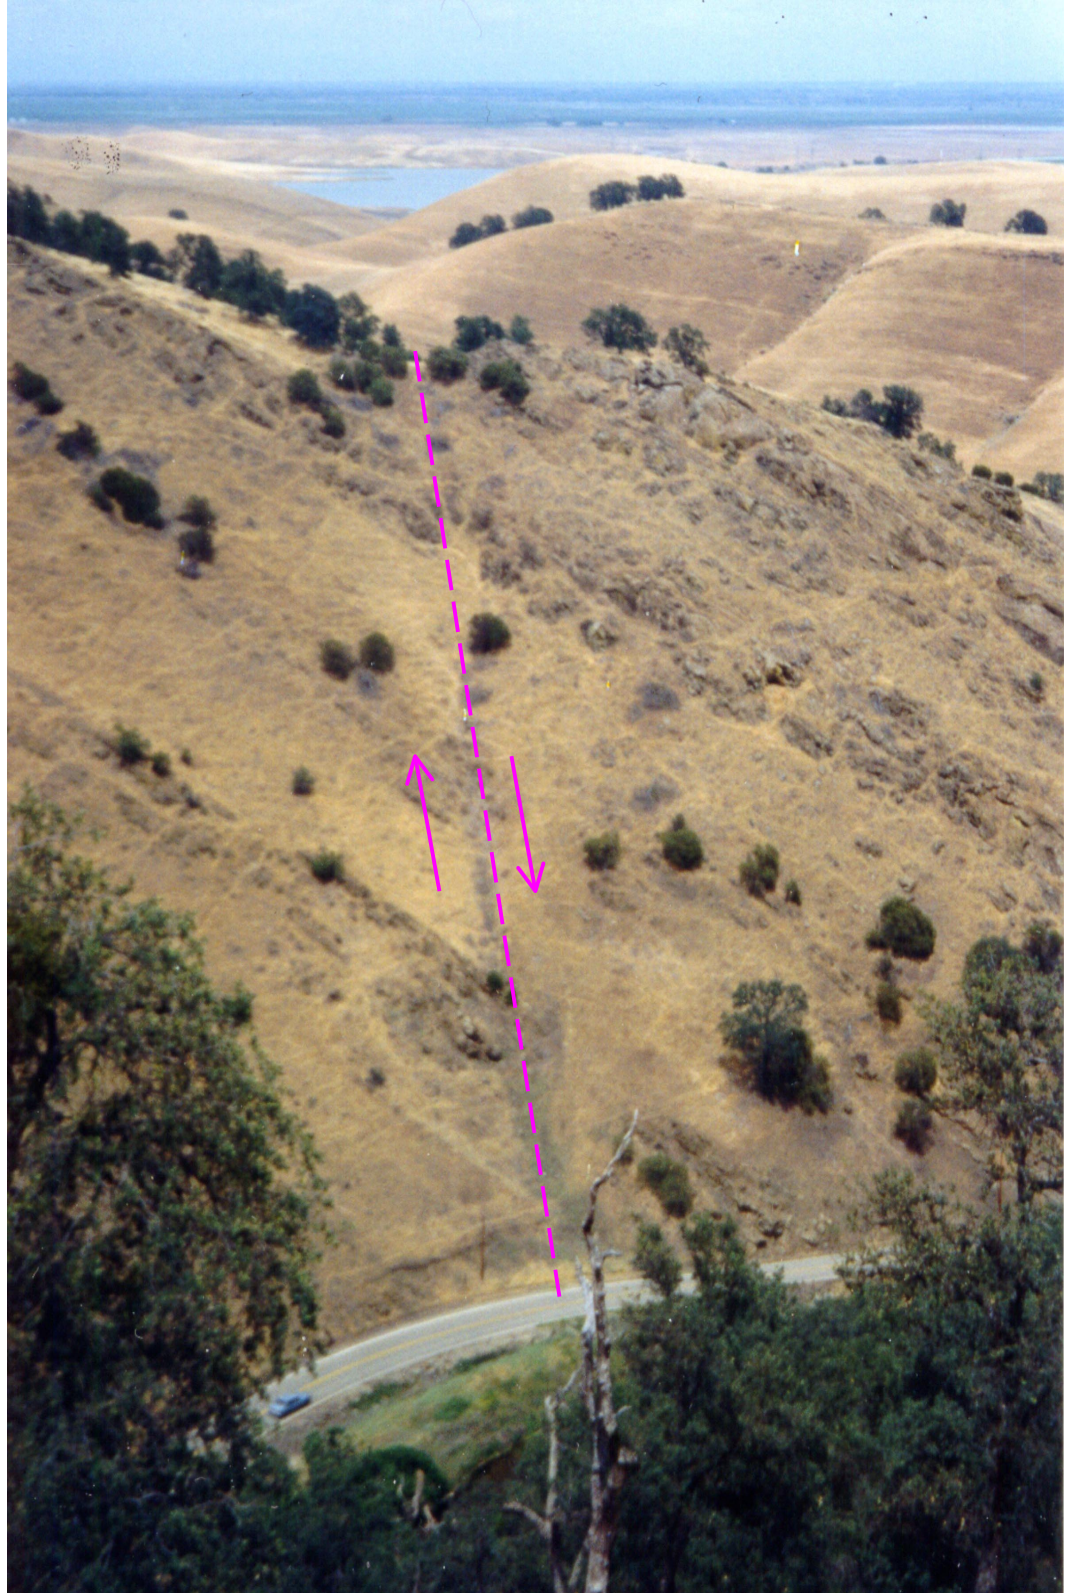
Fault S-2 was mapped by USGS (Calif., Glenn and Colusa Counties 1961) as a northeast-trending right lateral tear fault (Photo 3). It extends from near the town of Sites and trends about N70°E across the right abutment just above the dam crest, crossing the channel just downstream of the toe of the footprint, trending more northerly on a bearing of about N40°E (see Plate 2). This right lateral fault has an apparent offset of about 120 feet.

**Photo 3. NE view of S-2 fault downstream of proposed Sites Dam footprint.  
(Note Funks Reservoir in the background)**

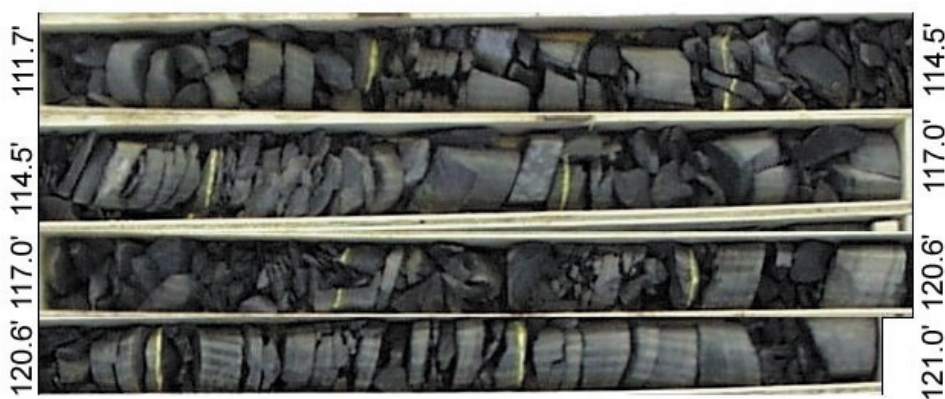
Angle drill hole LC-2 was drilled to evaluate the possible existence of the Salt Lake fault or associated deformation in the upstream footprint of the proposed dam axis (Photo 4). It was oriented cross-channel at S62°W to also explore the possibility of a "blind" or hidden fault under the alluvium that trends nearly parallel with Stone Corral Creek. It was drilled to a total depth of 202.2 feet. The upper 0.0 to 20.5 feet are composed of terrace deposits consisting of a mostly lean clay. From 20.5 to 39.0 feet, the hole drilled through 80 percent mudstone with 20 percent siltstone interbeds. From 39.0 to 50.7 feet, the hole drilled through 50 percent mudstone and 50 percent siltstone interbeds. From 50.7 to 72.0 feet, it intersected 80 percent sandstone with 20 percent mudstone interbeds. From 72.0 to 202.2 feet, the hole drilled through 80 percent mudstone with 20 percent sandy siltstone interbeds. It also intersected minor shears from 39.7 to 39.9 feet, 194.2 to 194.7 feet, and a shear zone from 111.7 to 121.0 feet. These zones contained slickensides and fracturing that may be related to the S-2 fault (Photo 5).

**Photo 5. Intense fracturing from 111.7 to 121.0 feet in drill hole LC-2**

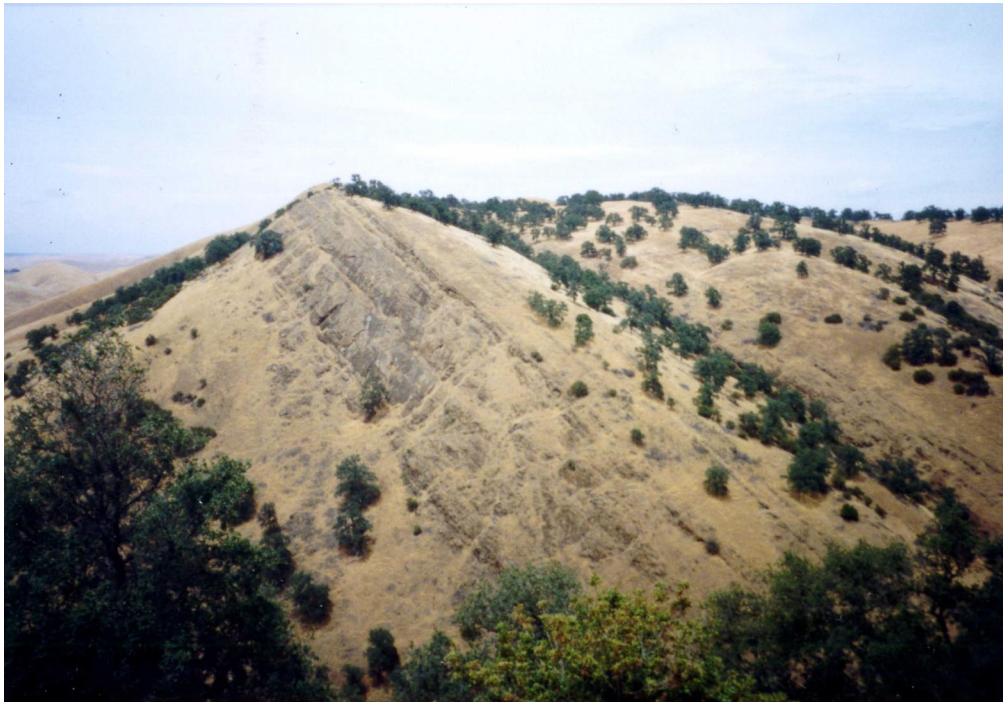
**Photo 6. Sites Dam site left abutment**

The left abutment is moderately steep adjacent to the channel section. It has a slope ranging from 1:1 at the base, then lessening to 0.75:1 towards the crest. (Photo 6). The sandstone forms the topographic highs often void of soil cover. Mudstone is mostly subdued in topographic expression and develops a colluvial soil overburden. These beds strike nearly north-south and dip about 50 degrees

The unconsolidated deposits on the left abutment consist of about 74 percent colluvial soil and 26 percent landslide deposits. This is underlain on average by about 55 percent sandstone and siltstone, with 45 percent mudstone interlayers.

Foundation preparation should include the removal of at least the upper foot of colluvial soil, landslide material, and heavily weathered bedrock using common methods, with another 14 feet of moderately weathered bedrock that may have to be excavated. The material removed from the foundation stripping probably can be used as random fill. The upper 1-foot of soil, colluvium, and intensely weathered bedrock on the left abutment can be stripped using common methods.

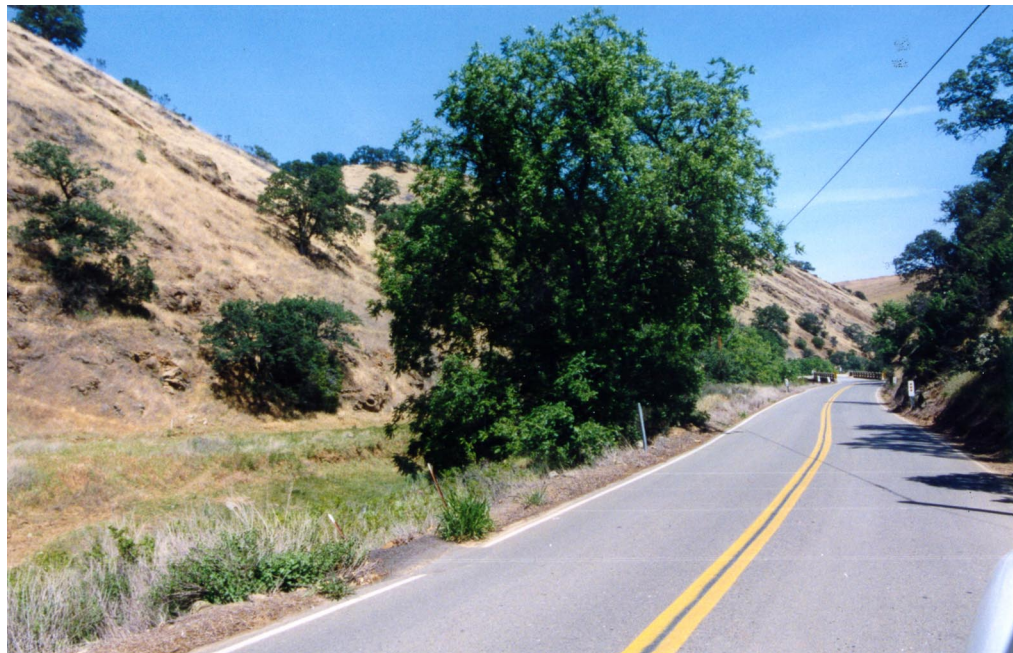
**Photo 7. Downstream view of the channel at Sites Dam site**

The channel varies in width from about 75 to 450 feet in the footprint, and averages about 150 feet at the dam axis (Photo 7).

Alluvial cover is superficial with about 4 to 10 feet of poorly to well-graded sand and gravel. No bedrock was observed in the channel of Stone Corral Creek within the footprint of the dam. The creek has perennial flows, so a creek diversion or impoundment will be necessary. The flow in the summer and fall is generally minimal, and dewatering will not be a serious problem.

Foundation preparation should include the removal of 4 to 20 feet of alluvium, terrace deposits, and intensely weathered bedrock using common methods, with at least another 9 feet of moderately weathered bedrock that may have to be excavated. In addition, the oversteepened slopes adjacent to and cut by the creek will require shaping.

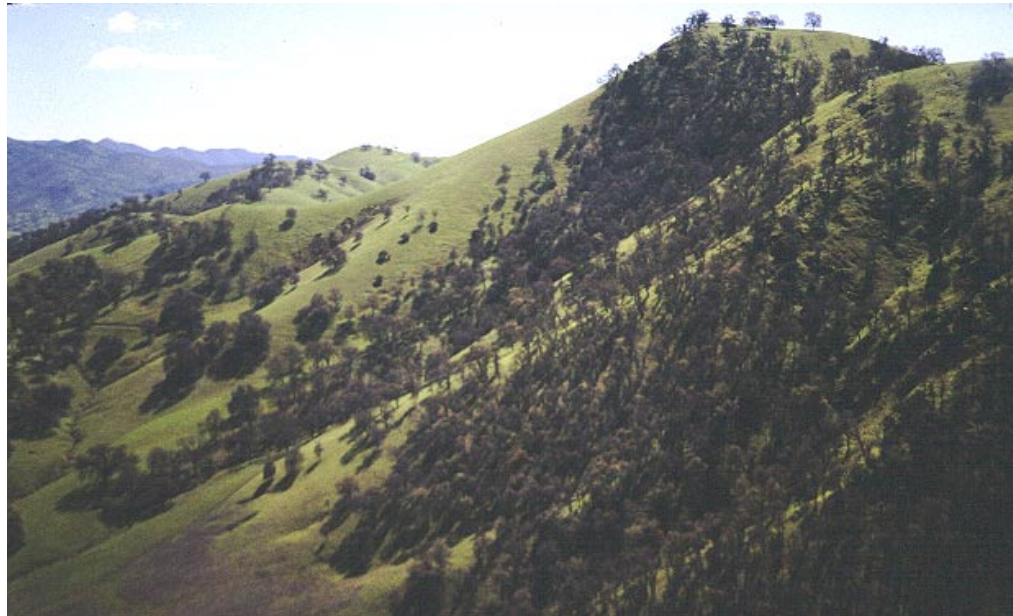
**Photo 8. Sites Dam site right abutment**

The right abutment is moderately steep with a natural slope of about 0.75 to 1 (Photo 8). The mudstone units mostly upstream of the dam axis are mostly covered by soil creep and/or colluvium and are generally only seen exposed in creek beds, roadcuts, and drill core. The sandstone can generally be observed as outcrops exposed as topographic highs with little or no soil cover. Minimal amount of colluvium and slope wash covers the mid to lower right abutment

There are thicker soil and colluvial deposits on the Boxer Formation than on the Cortina because the Boxer contains a greater relative percentage of more erodible mudstone. The unconsolidated deposits on the right abutment consist of about 57 percent colluvial soil and 43 percent landslide deposits. This is underlain on average by about 40 percent sandstone and siltstone, with 60 percent mudstone interlayers.

Foundation preparation should include the removal of at least 9 feet of topsoil, colluvium, heavily weathered bedrock, and landslide and rock debris. In some locations intensely weathered bedrock can be excavated using common methods, with at least another 40 feet of moderately weathered bedrock that may have to be excavated. A reconnaissance-level investigation of Sites Dam site states, "Depth to groutable rock on the left abutment will average three feet. Deep slope wash accumulations on the right abutment will necessitate 10- to 15-foot excavations to reach groutable rocks. Depths to groutable rock in the channel section will vary from five to eighteen feet. Temporary slopes of 1:1 on the
